An Arboricultural Report on Trees for

Durrington Town Council
Durrington
Wiltshire

Winter 2025

Prepared for Durrington Town Council

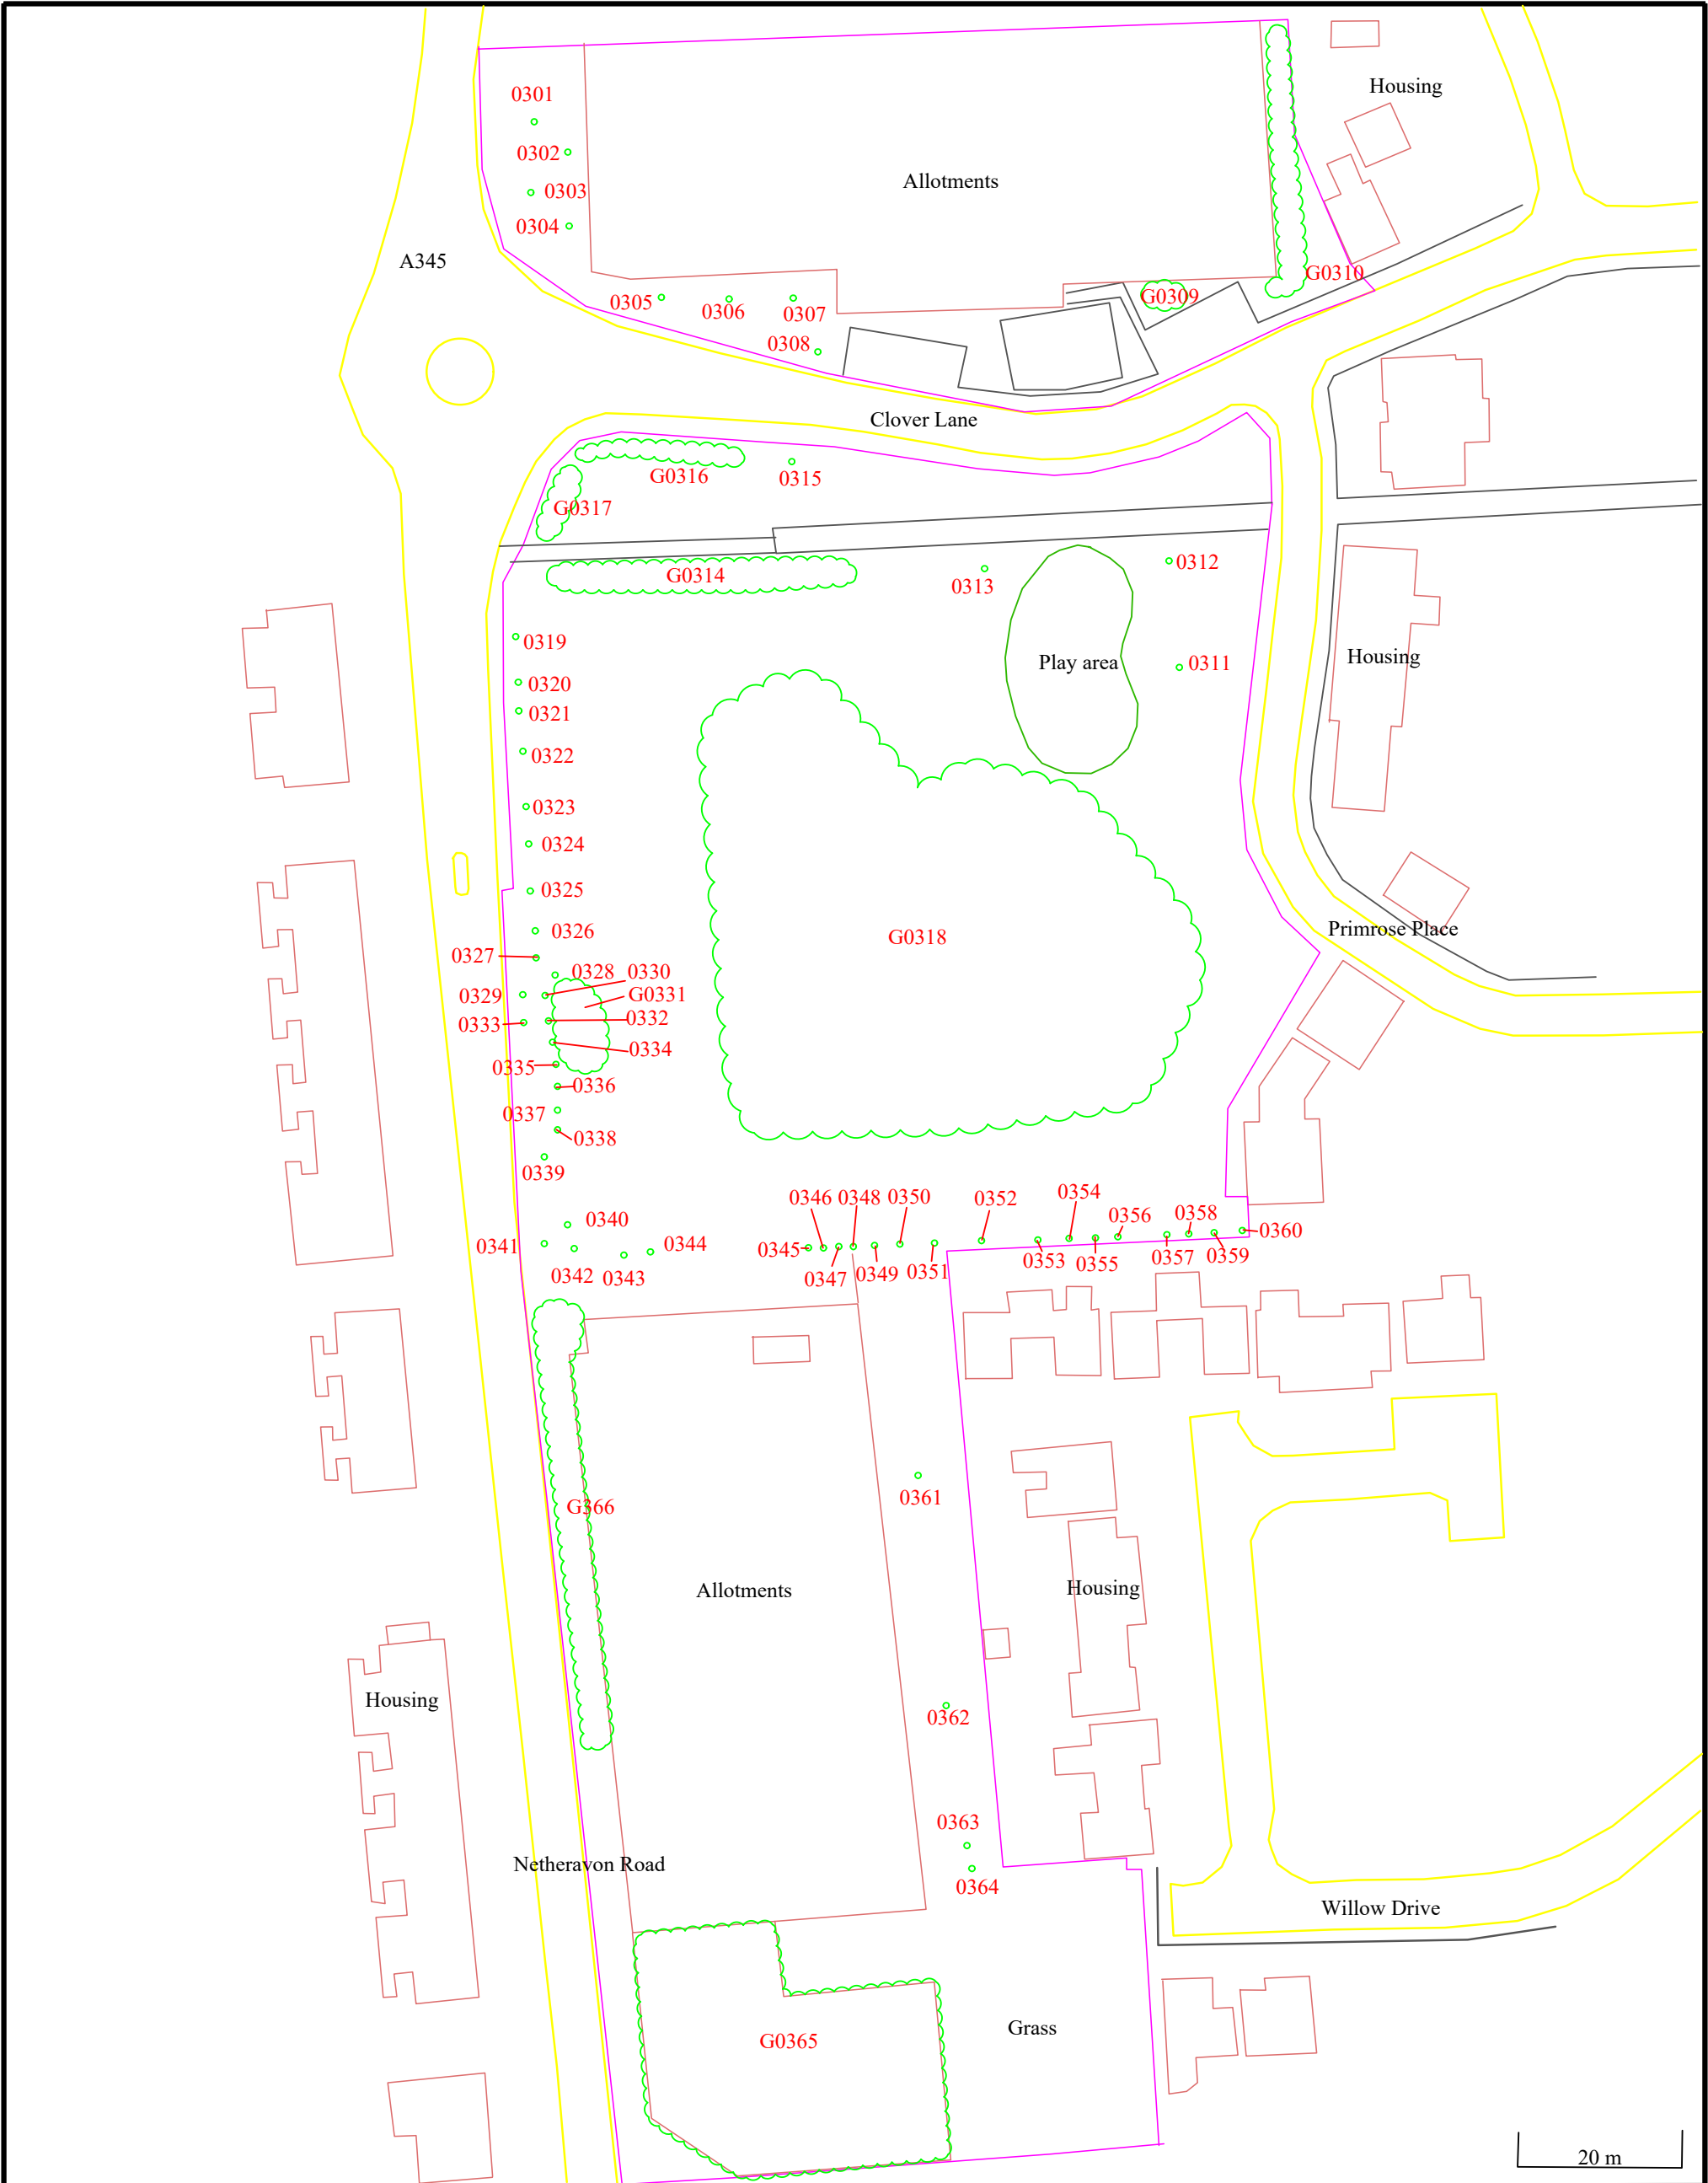
1. Avon Fields Meadow, Allotments & Millenium Park Allotments - Site Sketch Plan

Appraisal: The area of young woodland, G0318, was planted around 15 years ago, unfortunately the Goat Willow has established better than some of the other species and dominates the canopy cover. This is not ideal as Goat Willow, although a native species, is rapid growing and can have a tendency for failure. It coppices well, grows back from ground level when cut. I would advise instigating a program of coppicing/cutting sections of the Goat Willow to control this species. This would lower the risk of the Goat Willow becoming too large and increase species diversity whilst still maintaining tree cover. This could be with some community involvement.

The line of Sycamore between Avon Fields and Millenium Park have been topped, the removal of all foliage to leave a pole. This is against industry best practice and drastically shortens the lifespan of the tree. Topping leaves large cuts exposing the timber of the tree to decay micro-organisms. The foliage removal also stimulates growth so the trees attempt to grow whilst preventing decay. As the regrowth increases in size and weight it is more prone to failure than a natural branch structure. This regrowth will need to be controlled for the remainder of the lifetime of the trees, it does not need to be controlled at present.

- Consider coppicing Goat Willow in G0318

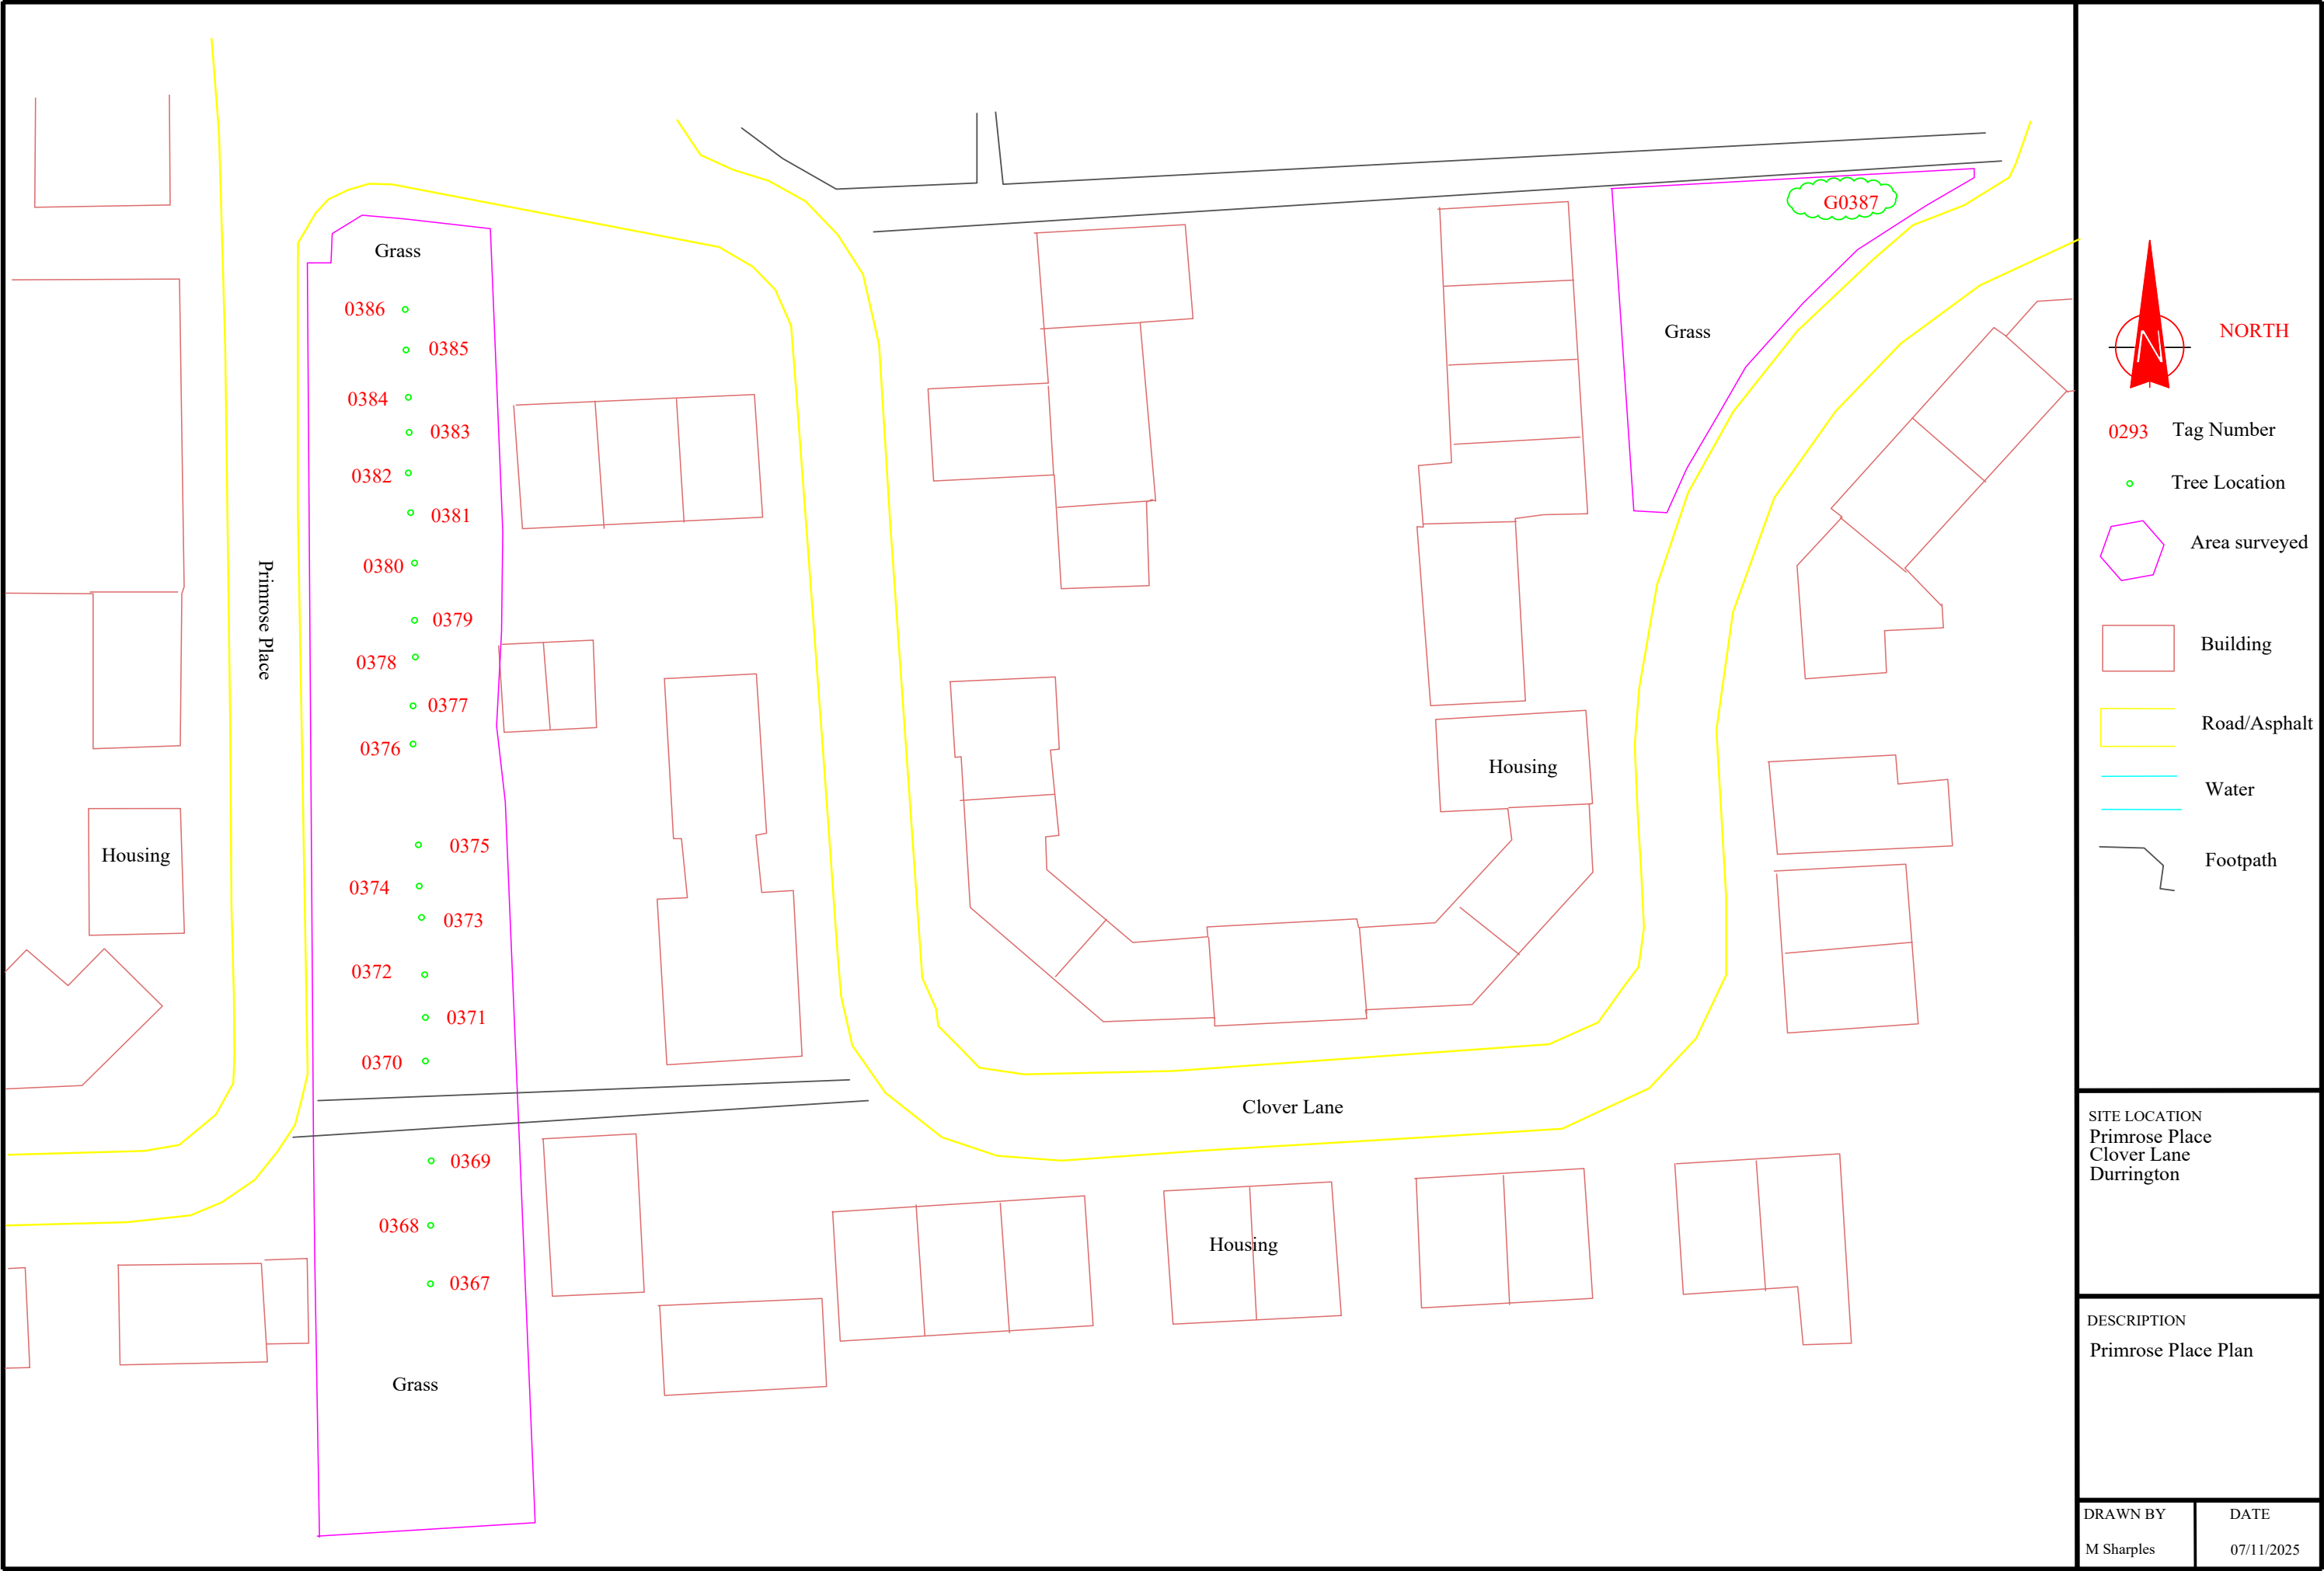
2. Primrose Place - Site Sketch Plan

Appraisal: The line of Sycamore in Primrose Place have been topped, the removal of all foliage to leave a pole. This is against industry best practice and drastically shortens the lifespan of the tree. Topping leaves large cuts exposing the timber of the tree to decay micro-organisms. The foliage removal also stimulates growth so the trees attempt to grow whilst preventing decay. The regrowth is predominantly around the cut points, where there is an increased likelihood of decay. As the regrowth increases in size and weight it is more prone to failure than a natural branch structure. This regrowth will need to be controlled for the remainder of the lifetime of the trees, it does not need to be controlled at present. Some of the trees have some Ivy growing up them, this would not be a concern in a healthy tree but due to the past pruning history there is a risk the Ivy could dominate the poles and prevent re-growth. There is some self seeded scrub, young Elm suckers and epicormic growth at the base of some of the Sycamores. This is not a hazard but its removal will improve aesthetics and open sight lines around the trees.

- Kill Ivy
- Remove scrub/young Elm

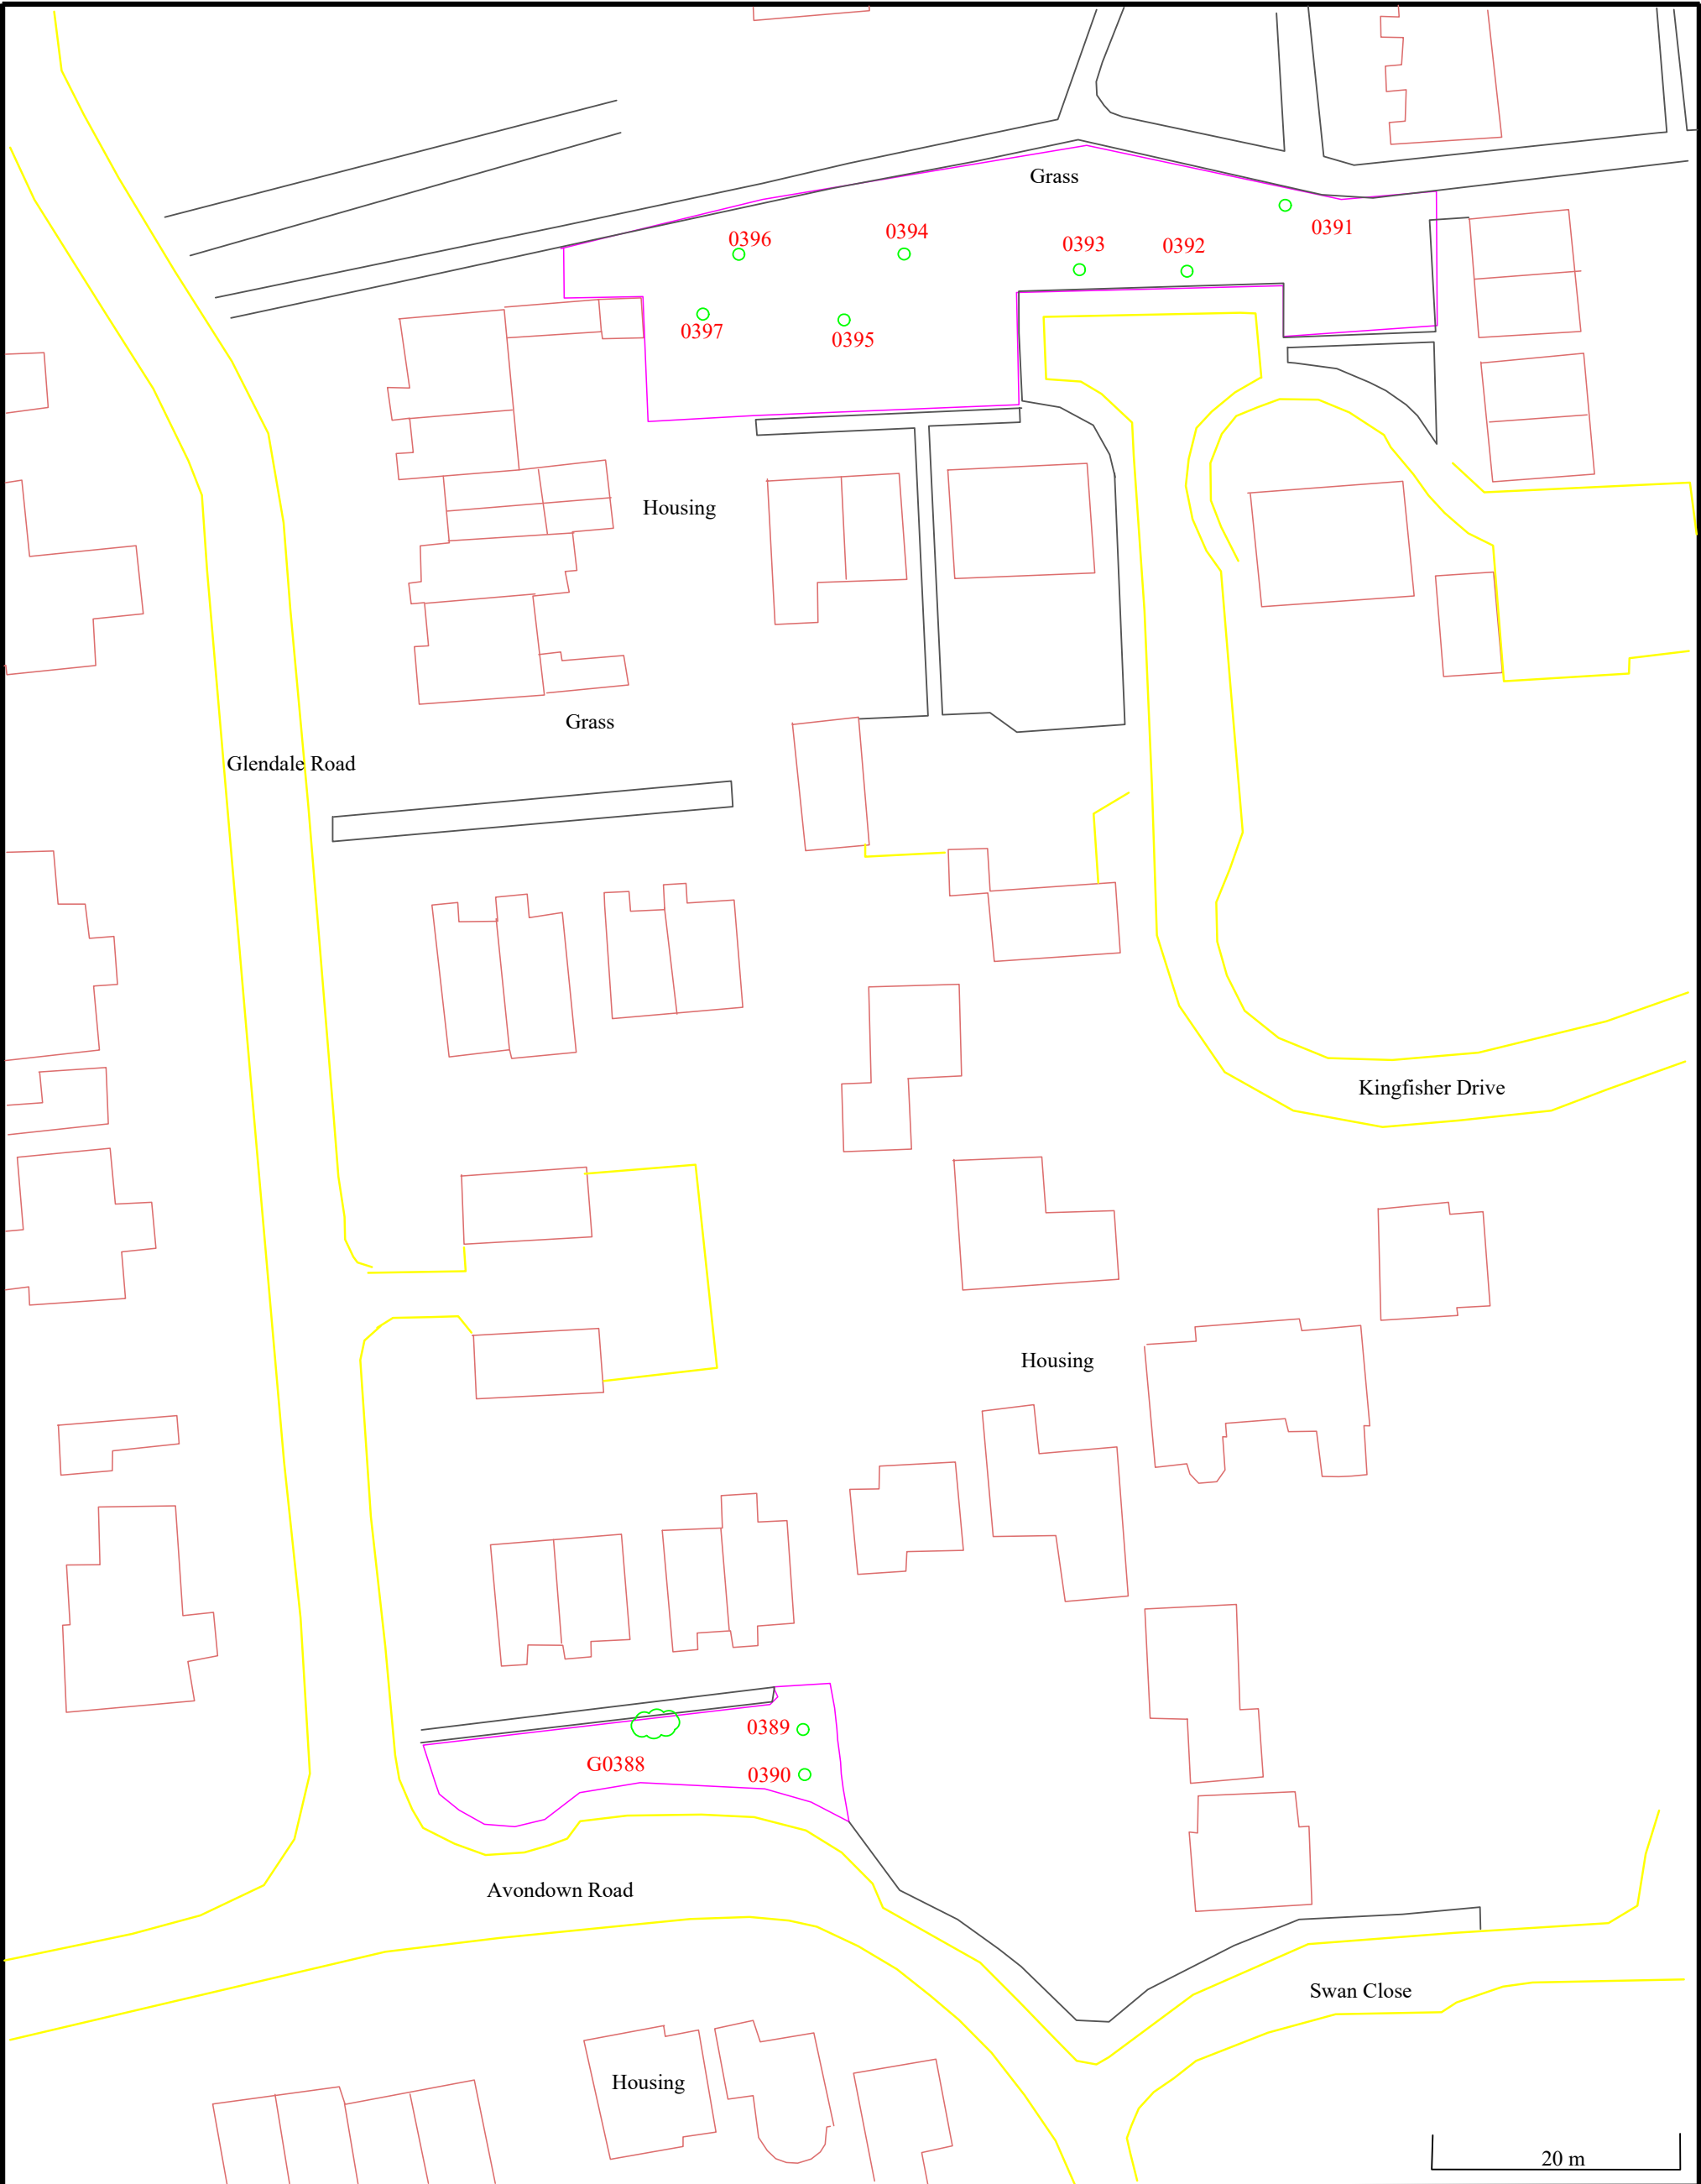
3. Kingfisher Drive - Site Sketch Plan

Appraisal: There are Ash trees on site, none are showing symptoms of the disease Ash Dieback, this has become endemic across the country over the last 15 years. The level of infection and eventual fatality rate is not currently fully understood. Current industry advice is that Ash trees provide valuable habitat and should only be removed when their safety becomes a concern. The Ash trees were not showing symptoms at the time of my survey but the disease can have rapid effects so the trees should be regularly monitored.

- Monitor for Ash dieback

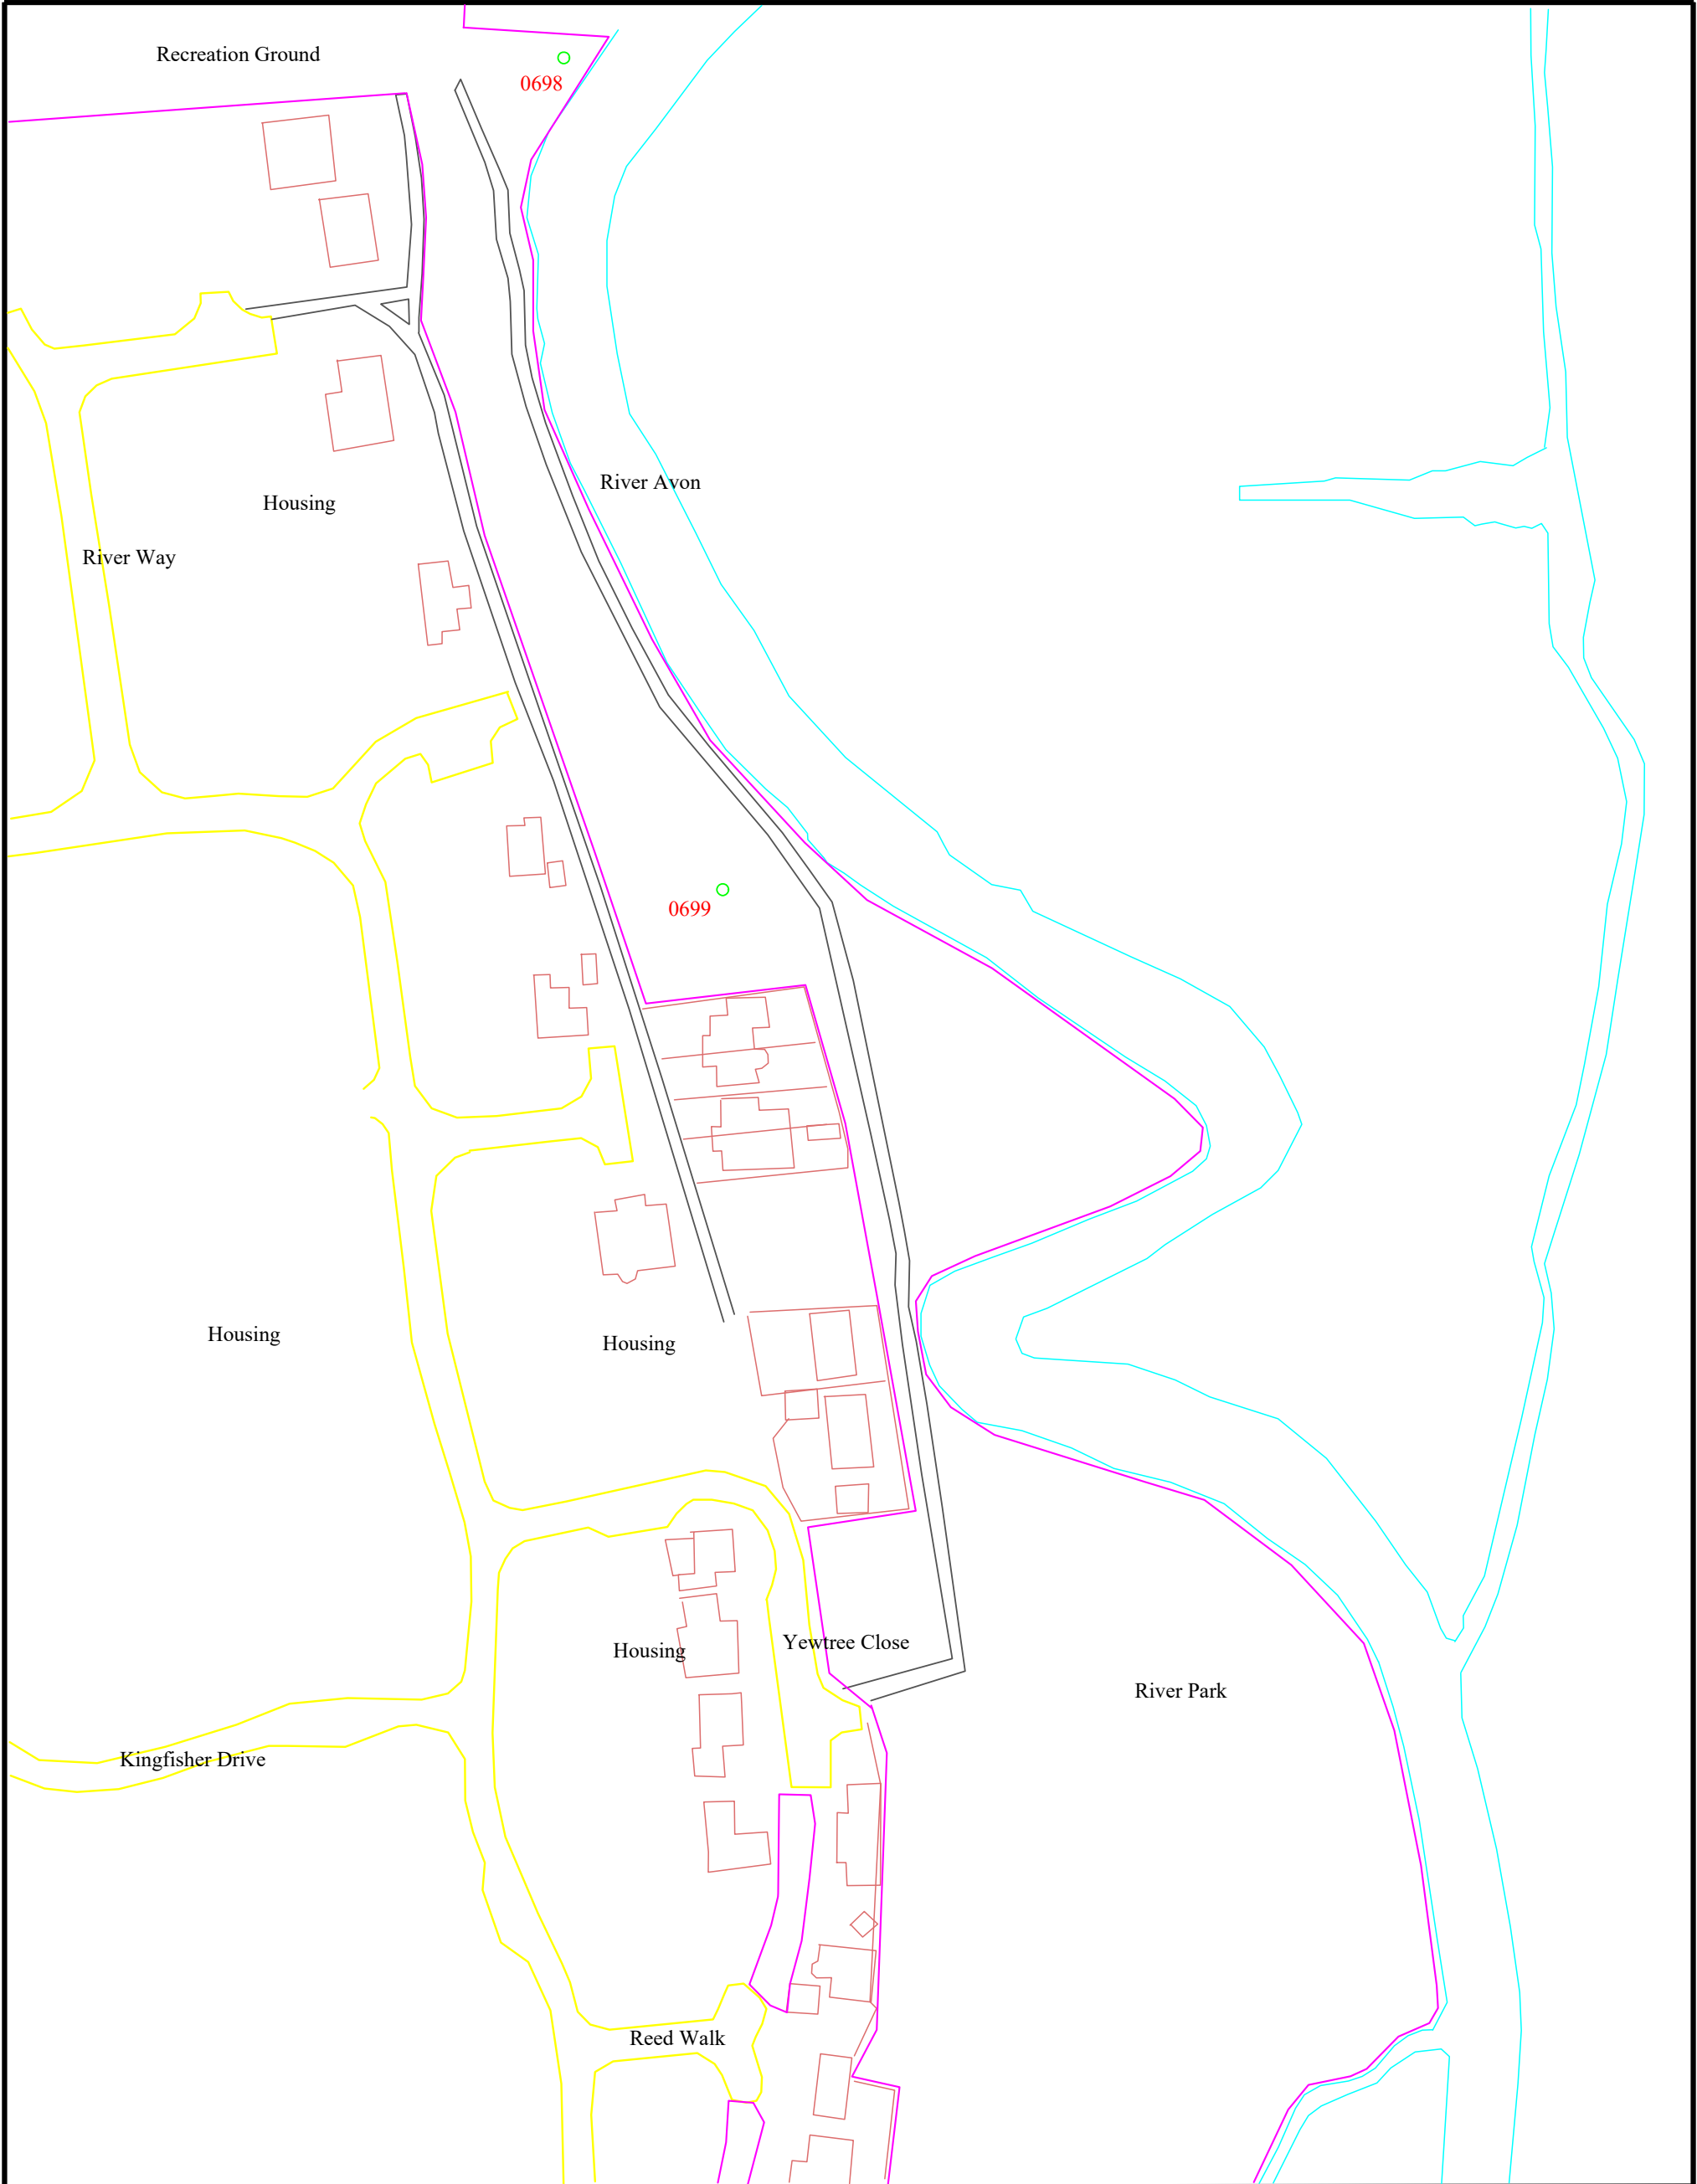
5. River Park North - Site Sketch Plan

Tree No	Species	Height	Dia @ 1.5m	Crown Spread	Maturity	Vitality	Observations	Recommendations	Grade
0698	White Willow <i>Salix alba</i>	10	5 x 700	3	Mature	Good	Divides at ground level. Pollarded at 5m. Central columns of decay in several stems.	Repollard	2
0699	Robinia <i>Robinia pseudoacacia</i>	13	2 x 500	6	Mature	Average	Previous stem failure to east, remaining 2 stems splitting apart	Fell	1
1	Goat Willow <i>Salix caprea</i>	8	10 x 250	8	Mature	Good	Divides at ground level. Several past failures. Snapped hanging limb over desire line.	Remove snapped hanging limb - spray marked. W3W - ///push.clock.servicing	1
